**OPTIMUS 50 kW generator**
**PCB kV control EZ130 modification instruction**
**for all PCB's 4512 108 05843/4/5** for Optimus 50kW
and 4512 108 08661--4 for 65/80kW

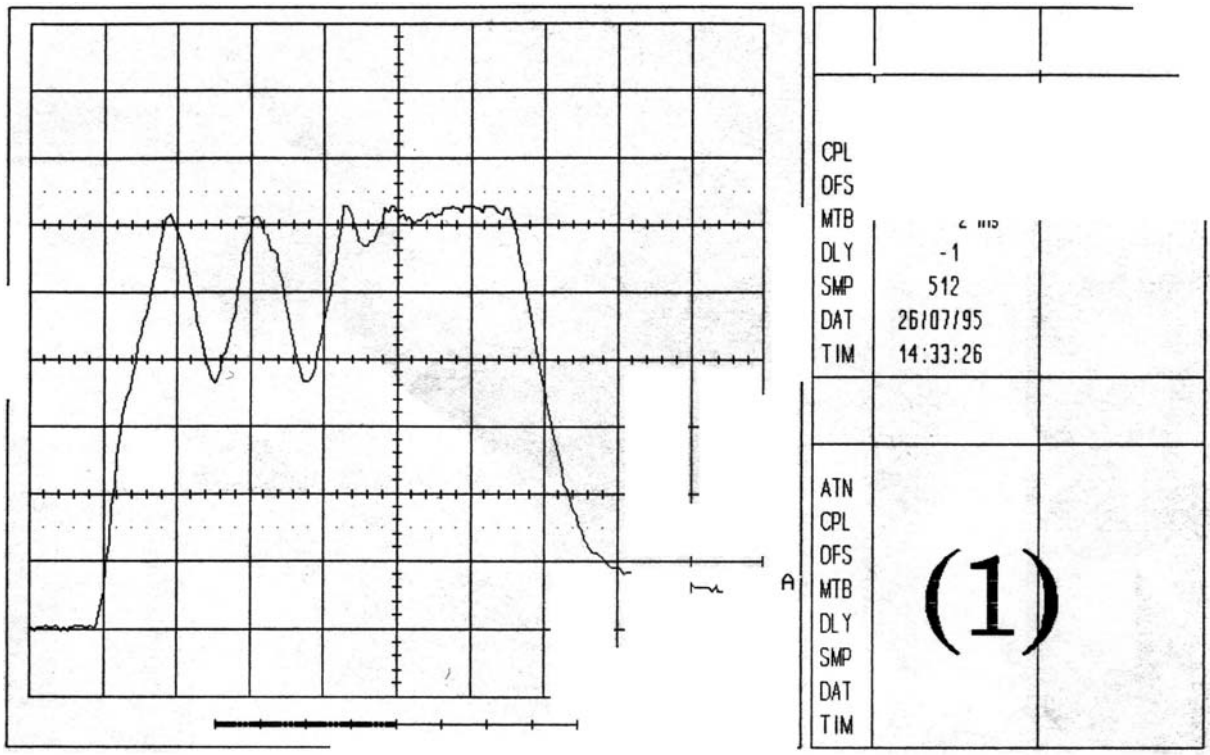
With the 50kW OPTIMUS generator, which has only one kV_power part to feed the primary side of the HV tank, it might happen, that some errors occur during installation. Sometimes these symptoms happen after installation under certain circumstances.

The errors coming up are (most of he time all together)

| 02HG | warning | kV actual value out of range | ±(4% +1kV) |
| 02HH | error | dto. | 20kV > U > 170kV |
| 03PA | emission current zero measured. | | |

The kV waveform, measured at EZ130 X3 (total kV) against EZ130 X6 (ground), might look like the attached scope pictures (1) and (2) in any kV stage.
Scope settings:
- 1V/div (20kV/V)
- 2ms/div
- trigger with positive slope (kV rise) or external trigger CTRL_X_C/ EZX74 negative slope (backpanel measuring point).

If the errors are coming up and/or the kV waveform is similar to the scope pictures (1) and/or (2) then solder an additional resistor parallel to resistor R226 on PCB EZ130 kV_control.
X The value is 475kΩ ⅛W (12NC 2322 156 14754), the position on the PCB is given on the layout drawing.

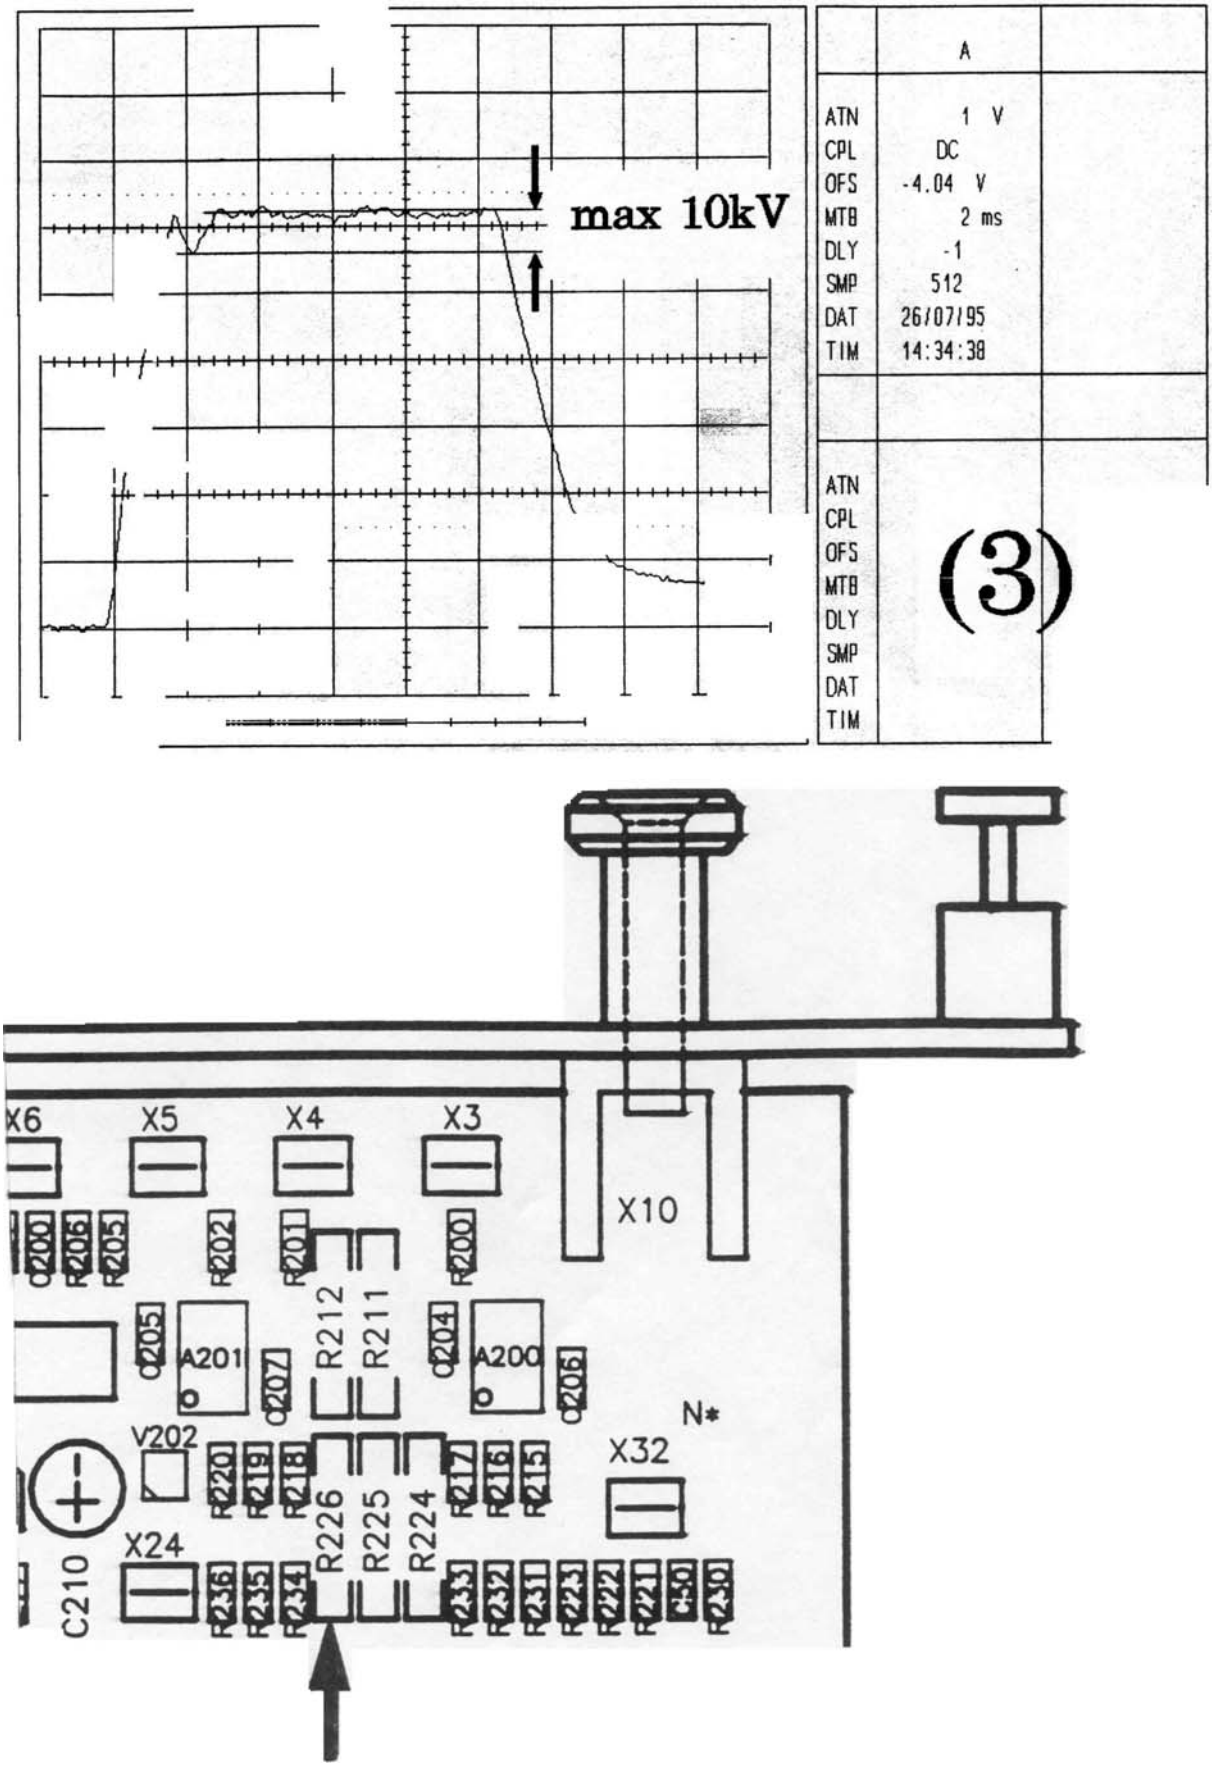
The 'swing' of regulation should not increase 10kV (see scope picture (3)).

X Also possible: 392kΩ
475kΩ
562kΩ
681kΩ
825kΩ
1MΩ
